During the post-construction period, the Southern part of 'Calcutta Metro Railways' had a serious problem of inflow of water in the box tunnels through different locations which even affected the running of Metro Coach. The sources of water ingress were:

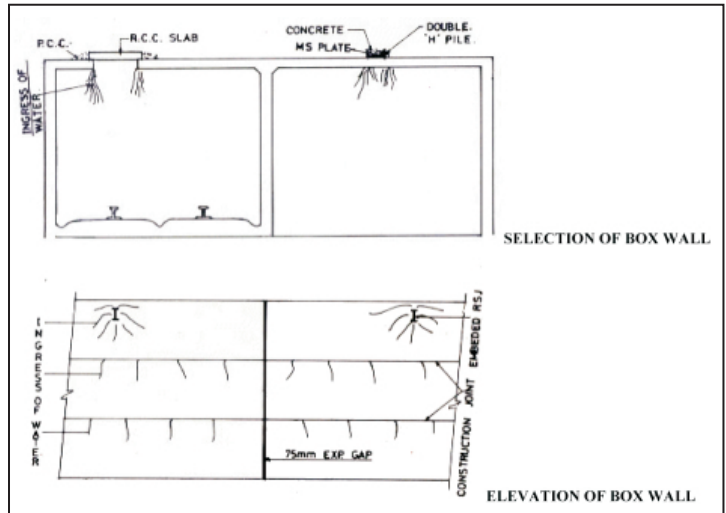
*The leakage points were mainly:*

- Construction joints
- Expansion joints
- Joints between the entry structure and main box
- The area surrounding the embedded inserts (the end pieces of RSJ used as struts and double 'H' piles used as columns during construction period).
- The periphery of the openings kept over the roofs slab at a distance of 1 km apart to facilitate the lowering of 13m long rails and other tracks fittings, which were subsequently covered with RCC slab and concrete and then back filled.
- A large opening provided for lowering the coaches through the openings was subsequently sealed with RCC slab and concrete and back filled.

The water was found to be flowing incessantly round the clock and in most of the places gushing in the form of jet. As such utilisation of cement as grouting material was out of the question. To tackle the situation "Expansive Aqua-Reactive Water Barrier and Grouting system known as Polygrout was found to be ideal.

Polygrout is a low viscosity liquid, which reacts with water in a controlled manner to form a swelling resilient adhesive solid. When impregnated under pressure into leaking structures and through the process of polymerisation, a permanent flexible water barrier is formed.
