- 1) The power house of the **Chamera Hydroelectricity Power Project** is situated at Khairi in the Chamba district of Himachal Pradesh, India. The installed capacity of the project is 540 MW with 3 Turbine generators of equal capacity. The three generators are fed from a common tunnel which is near the surge tank into the three penstock tunnels. The project is under the aegis of the **National Hydroelectricity Power Corporation (NHPC)** India.
- 2) The NHPC officials had been plagued with continuous water leakages inside the penstock tunnels. Unable to solve this vexing problem, NHPC officials approached **CICO** Group of companies to inspect the locations of water ingress and to suggest immediate remedial measures to stop the water leakages, as continuous leakage of water inside the penstock could lead to serious damages.

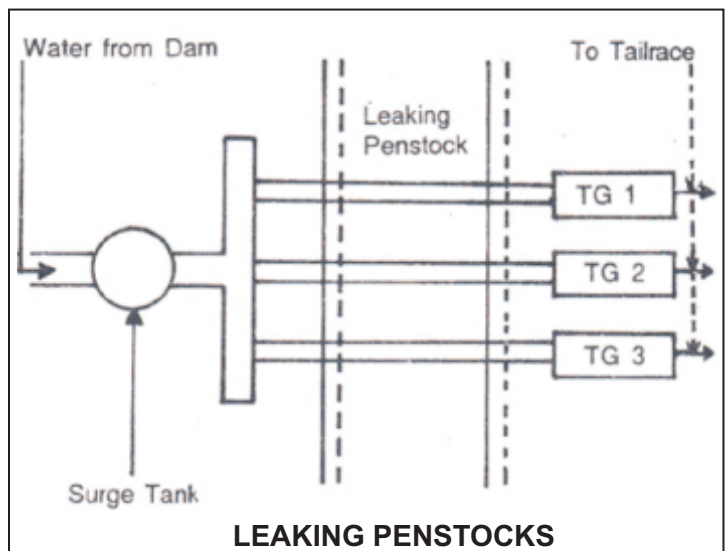
- 4) The surrounding rock of the tunnels had been grouted by cement grouts through deep holes inside the rock. These holes are referred as direct holes. However, leakages from these direct holes were more pronounced in the upper half of the tunnels. In addition, high leakage concentration was found near the construction joints of the concrete lining of the tunnels.

- 5) *The rectification work consisted of:*
 1. Injection of **POLYGROUT** in direct holes through which water was leaking.
 2. Injection of **POLYGROUT** at construction joints, by drilling holes.

- 6) In both the cases 100x6 mm diameter nozzles were used through which **POLYGROUT** was injected under a maximum pressure of 2 Kg/Cm². The nozzles were fixed in the newly drilled holes near the construction joints or in the direct holes by means of quick setting mortar which attains stability within 10 minutes of mixing. **CICO** No.3 along with ordinary Portland Cement provided the Quick setting compound.
