NORTH EASTERN ELECTRIC POWER CORPORATION OF INDIA LIMITED commonly known as **NEEPCO** had some problems in the intake tunnel of their Hydro Electric Power Plant in Kopili. Technician of **CICO** were called upon to provide immediate solutions to these problems. After thorough inspection of the site it was observed that in the ceiling of the intake tunnel at a distance of 1.2 km from the Surge Shaft towards the river, a crack had developed in oval shape, of 16 mt long and 3 mt width, resulting in the ceiling to hang literally from the top. The width of the crack varied from 5 mm to 150 mm. Water was oozing out of the cracks.

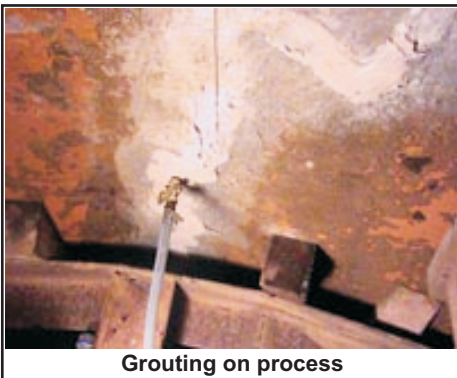
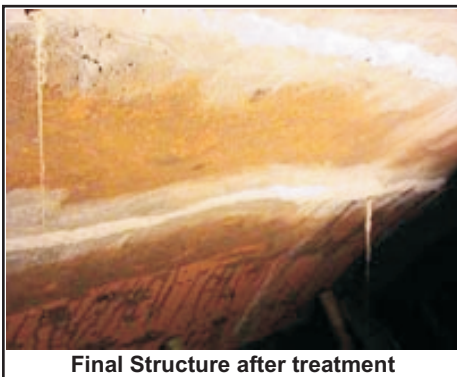
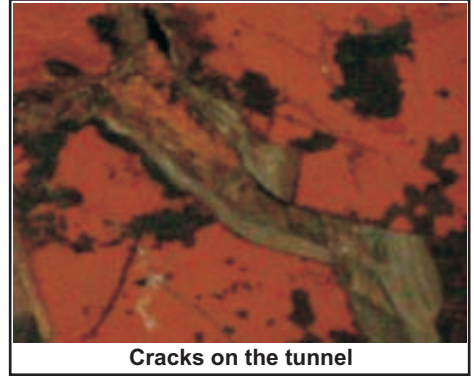
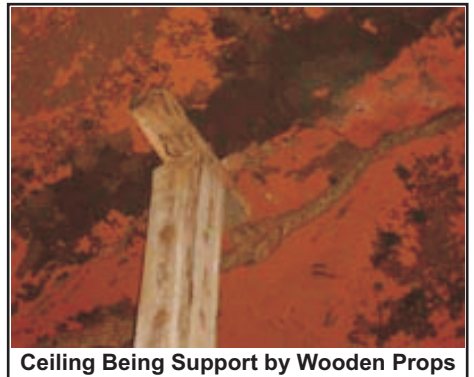
During the site investigation, **CICO's** experts have observed voids & honeycomb in the ceiling of the tunnel. Due to sudden decrease in pressure of the tunnel, as a result of emptying for cleaning purpose; the cracks developed.

Firstly wooden props and Bamboos were used to support the Ceiling and prevent it from further coming down during the process of treatment. Then the width of the crack was reduced from 150 mm to 25 mm with cement admixed with quick setting compound. Nozzles of varying depth from 4" to 18" were then fixed in the reduced gap @ 500 mm c/c with Epoxy putty. Water Insensitive Epoxy Grout was then injected through the alternate nozzles under pressure. After the epoxy was set, remaining nozzles were grouted with cement slurry admixed with non shrink Powder.

After the whole operation was over the props were removed and the structure was handed over to the **NEEPCO** authority within a span of 10 days to their satisfaction.
